PARKS SYSTEM

Playground Assessment

City of St. Ann

December 8, 2017

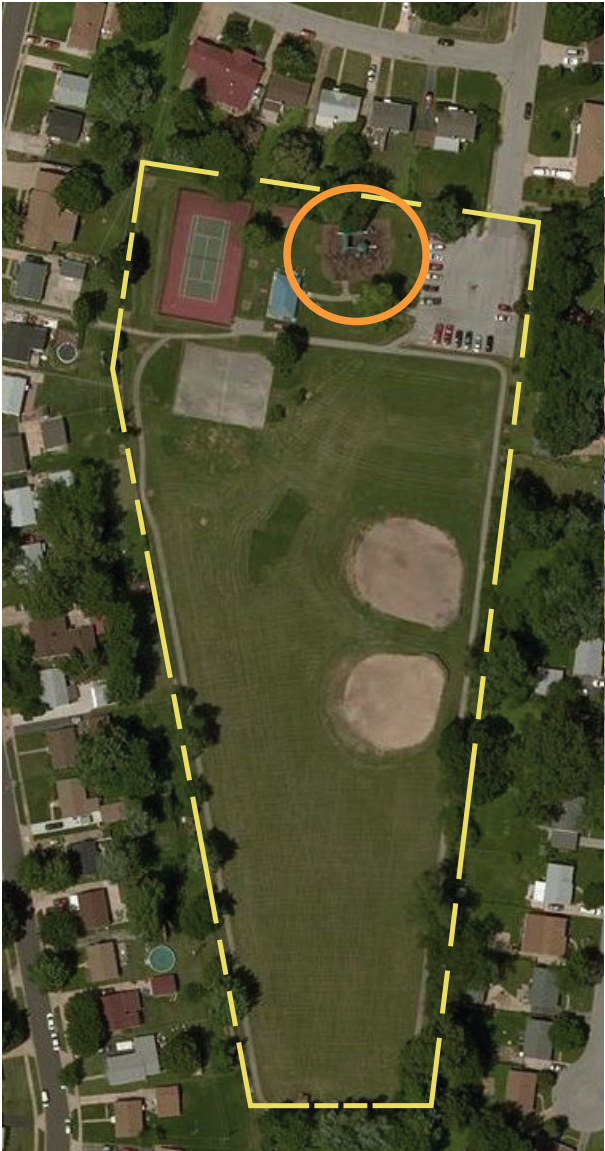
SCHAFER PARK

Schafer Park is a seven acre neighborhood park located on Wright Avenue in Ward 1. It has two baseball diamonds, two grills, one restroom, one horseshoe pit, two mini shelters, one pavilion, one playground, one tennis court, and a perimeter trail.

Schafer Park	Score	Comments	Recommendations
Structures & Location	Ward		One	
	Manufacturer		Playworld	
	Year Installed		2001	Annual inspection by a CPSI professional
Equipment & Accessibility	Age	0	Playground installed more than 15 years ago	City should consider replacement of the playground in long-range planning for the park
	General Conditions	2	Structures are in good condition with some fading of color and chipping of paint	Equipment is well-maintained and should continue so based on CPSI inspections until replacement
	Paved Accessible Walk	2	There is a paved walk to the playground, but it does not meet ADA requirements.	Renovate walk to make accessible with a minimum width of five feet. Extend walk to connect restroom and drinking fountain.
	Surfacing	2	Mulch	Install poured-in-place rubber surfacing with replacement to meet city's goal for playground surfacing
	Swings	0	There are no swings present.	Swings could be added to enhance the play experience if desired by the community

Schafer Park achieves the second-highest score of the playgrounds in the City of St. Ann parks system. Due to its high ranking and lower comparative usage, the recommendation for priority of replacement of this playground would be lower in comparison to other playgrounds.

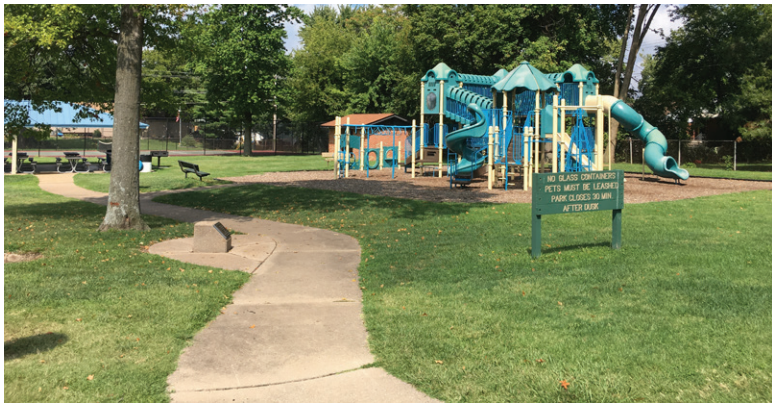
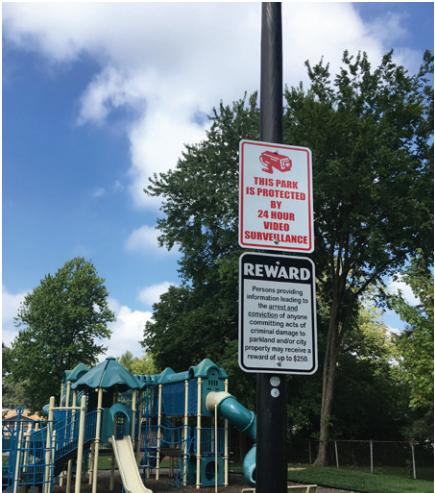
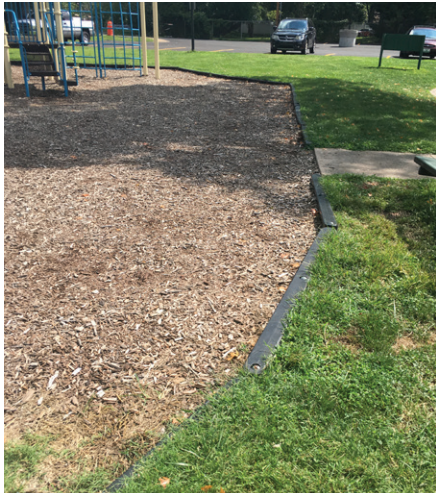
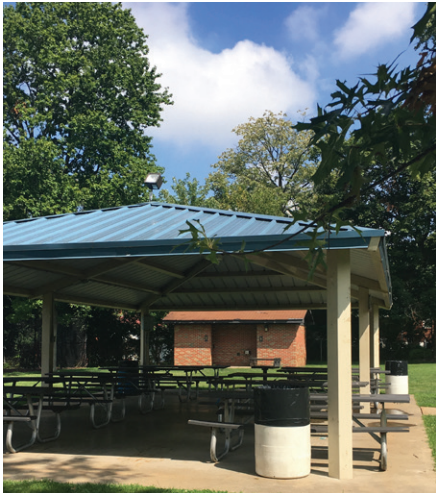
Schafer Park has a playground that was installed in 2001. The surfacing is wood mulch and several benches are provided along the perimeter of the playground. A shelter with picnic tables and a stand alone restroom building with drinking fountain are located in close proximity to the playground. A paved walk connects the parking lot, playground and shelter, but does not connect to the restroom building.

Inclusive Play	2	No inclusive play elements; park not used for major camps or events	This park is not used for events or camp, but could still benefit from the addition of an inclusive element(s)
Comfort & Convenience	Site Furnishings	1	Benches near playground, shelter with picnic table and trash receptacles nearby	Ensure these items meet ADA guidelines with future improvements
	Shaded Play Area	0	Trees are present but provide minimal shade	Consider successional planting of trees near play area
	Restroom	1	There is not a path leading to the restroom	Provide accessible path to the restroom
	Picnic Shelter	1	Picnic shelter present nearby	Maintain shelter and accessible connection to the playground and other amenities
	Drinking Fountain	1	Drinking fountain present at nearby restroom	Ensure drinking fountain meets ADA guidelines and provide accessible walk from playground
	Lighting (Security)	1	There is a light and camera near the playground	Security camera exceeds the current standard for playgrounds. Should consider this at all playgrounds where feasible

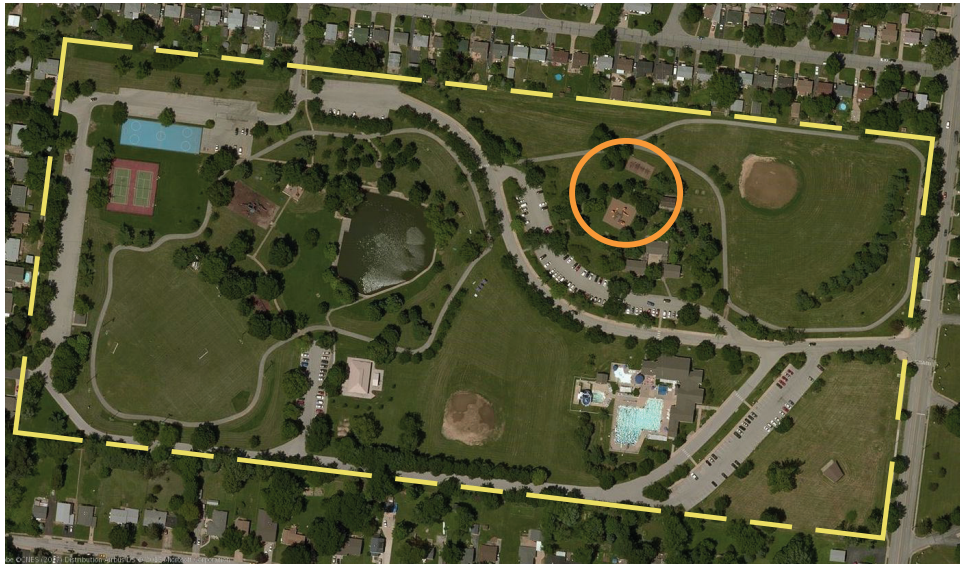
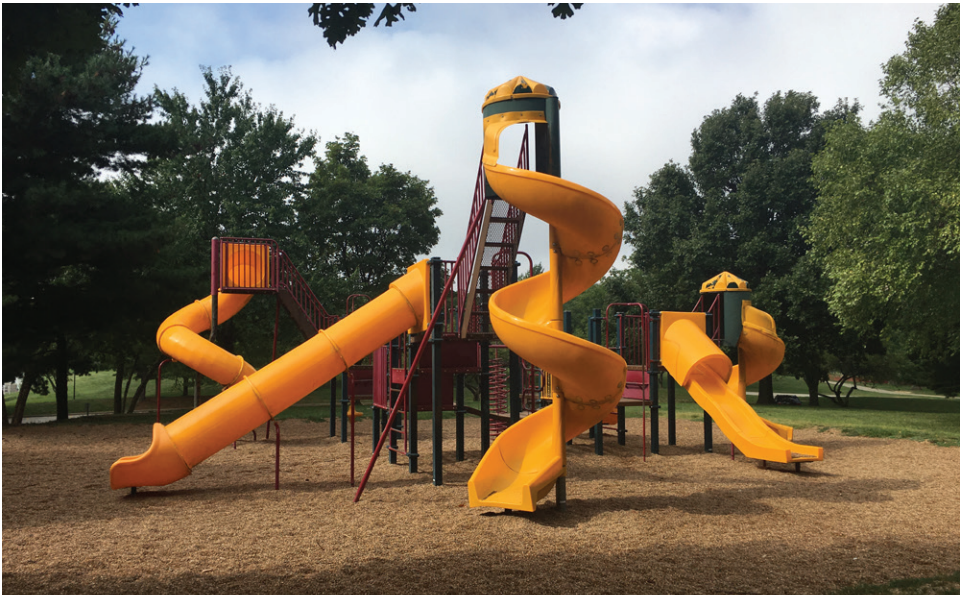
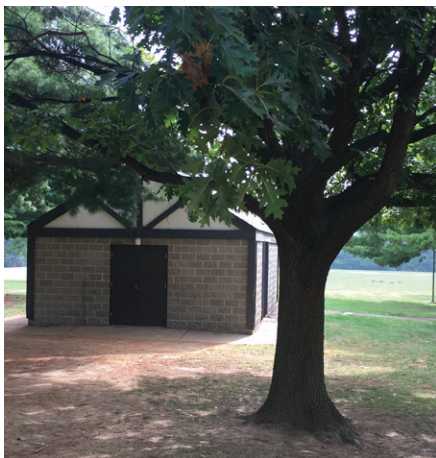
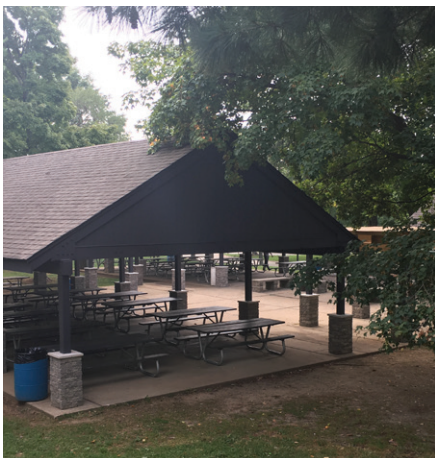
TIEMEYER PARK - Shelters 1-2-3

Tiemeyer Park has two playgrounds. This playground is located on the east end of the park near the tri-pavilion complex. This area of the park is highly active and is home to the park's summer camps.

This playground includes a Miracle play structure and a separate swing area that was added at a later date. The surfacing at the play structure is pea gravel and mulch surfacing is installed at the swings. There is a significant grade change from the shelters up to the playground, and there is no direct path to traverse this route. A restroom and drinking fountain are located nearby, but are not connected to the playground with an accessible route.

Tiemeyer 1-2-3	Score	Comments	Recommendations
Structures & Location	Ward		Three	
	Manufacturer		Miracle	
	Year Installed		1994	Annual inspection by a CPSI professional
Equipment & Accessibility	Age	0	Playground installed 15 or more years ago	City should consider replacement of the playground in long-range planning for the park
	General Conditions	2	Good condition, some chipped paint and tears in rubber coating	Equipment is well-maintained and should continue so based on CPSI inspections until replacement
	Paved Accessible Walk	0	No existing path	Accessible path to connect to play area, consider connecting to existing loop trail, restroom, and shelter
	Surfacing	0	Pea gravel	Install poured-in-place rubber surfacing with replacement to meet city's goal for playground surfacing. Mulch may be a temporary replacement to provide an accessible surfacing
	Swings	2	Swings nearby, there is no existing path to the swings	Add accessible path to swings, install rubber surfacing

Inclusive Play	0	There are no inclusive elements and the park is used for camps and events	Inclusive play would be highly beneficial as this park draws high traffic due to camps and events that are held in the park
Comfort & Convenience	Site Furnishings	1	Benches near playground and tri-pavilion shelter with many picnic tables	Ensure these items meet ADA guidelines with future improvements
	Shaded Play Area	0	No shade existing at playground	Consider planting trees near playground
	Restroom	1	Restroom nearby, no path from playground to access	Consider adding path to connect to play area
	Picnic Shelter	1	Large shelter nearby, no path to access from playground and significant slope	Consider adding path to connect to play area and mitigate slope
	Drinking Fountain	1	Drinking fountain existing at nearby restroom	Consider adding path to connect to play area
	Lighting (Security)	0	No lighting at playground	Consider adding lighting for safety and security

Tiemeyer Park - Shelters 1-2-3 Playground received the second-lowest score of all the playgrounds in the City of St. Ann system. Due to its high usage and the events that are held in the park, this playground is the highest priority for replacement. Additionally, due to the high usage and unique topographical aspects of the site, consideration should be given to a specialized type of playground experience as outlined in the appendix.

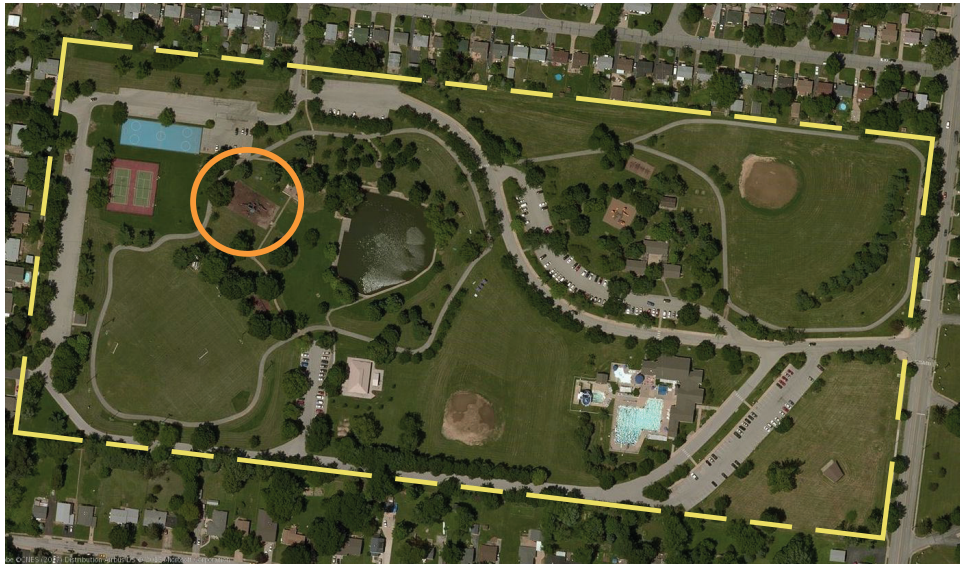
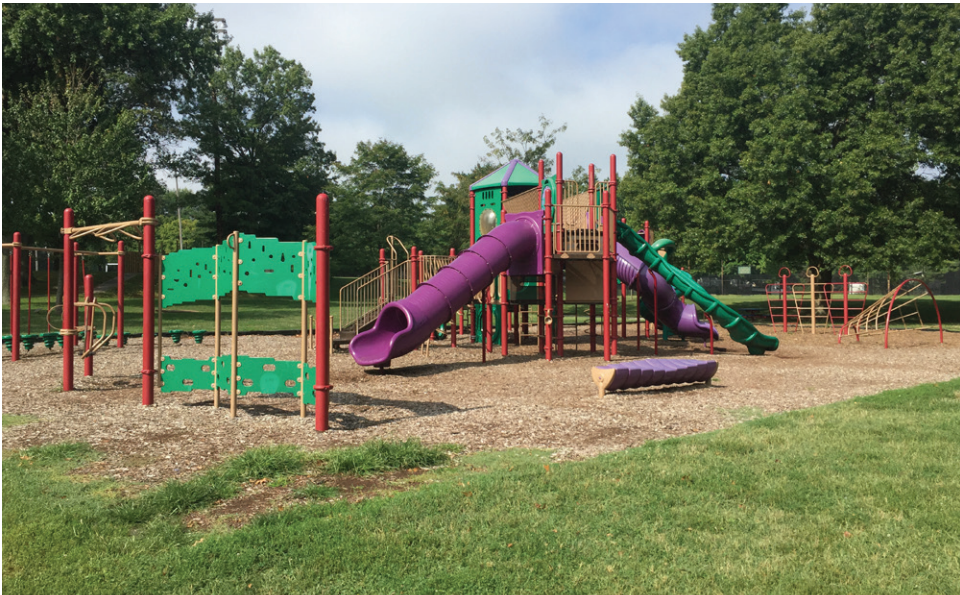
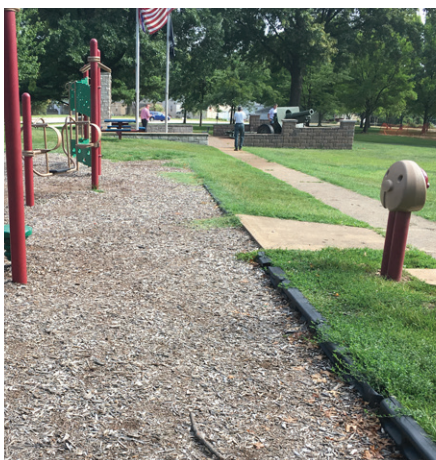
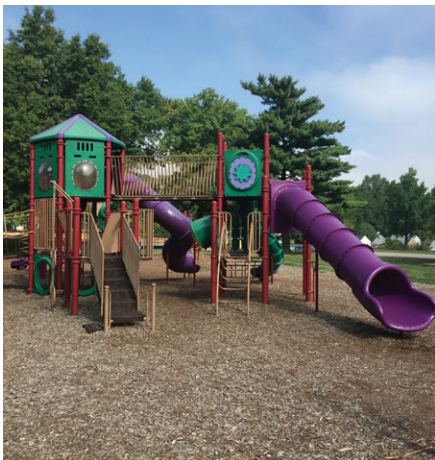
TIEMEYER PARK SHELTER #4 AND WAR MEMORIAL

Tiemeyer Park has two playgrounds. One has mulch surfacing and one has pea gravel surfacing. The playground with mulch surfacing is near the War Memorial. It was installed in 2002 from the manufacturer Miracle and has a paved walk to access the playground. There are swings nearby as well as benches at the edge of the playground. Shelter #4 provides a pavilion, restroom and drinking fountain near the playground. These amenities are located approximately 250' from the swing area.

Tiemeyer War Memorial	Score	Comments	Recommendations
Structures & Location	Ward		Three	
	Manufacturer		Miracle	
	Year Installed		2002	Annual inspection by a CPSI professional
Equipment & Accessibility	Age	0	Playground installed 15 or more years ago	City should consider replacement of the playground in long-range planning for the park
	General Conditions	3	Structures in good condition with minimal fading or chipping	Equipment is well-maintained and should continue so based on CPSI inspections until replacement
	Paved Accessible Walk	2	There is a walk to access the playground; it does not meet ADA requirements	Renovate walk to make accessible with a minimum width of five feet.
	Surfacing	2	Mulch	Install poured-in-place rubber surfacing with replacement to meet city's goal for playground surfacing
	Swings	2	Swings exist nearby	Add accessible path to swings, install rubber surfacing
	Inclusive Play	0	There are no inclusive elements and the park is used for camps and events	Inclusive play would be highly beneficial as this park draws high traffic due to camps and events that are held in the park

Comfort & Convenience	Site Furnishings	1	Benches are provided near playground	Ensure these items meet ADA guidelines with future improvements
	Shaded Play Area	0	There is no shade at playground area	Consider planting trees near playground or providing shade in another way
	Restroom	1	There is a restroom at Shelter #4	Shelter #4 provides this convenience, but it is a distance from the playground
	Picnic Shelter	1	Shelter #4 is approximately 250' from the swing area and 450' from the playground.	Shelter #4 provides this convenience, but it is a distance from the playground
	Drinking Fountain	0	There is a drinking fountain at Shelter #4, but the distance away is a challenge	While provided at Shelter #4 it is recommended an additional drinking fountain be provided closer to the playground
	Lighting (Security)	0	There is no lighting at the playground area	Consider adding lighting to the play area for safety and security

Tiemeyer Park Shelter #4 and War Memorial Playground is among the top three ranked playgrounds in the City of St. Ann parks system. While it is one of the newest playgrounds it is still older than fifteen years of age. It is in a park that hosts events and draws many visitors; however, due to its higher ranking and the prioritization placed on the other playground within Tiemeyer Park this playground is a low priority for replacement.

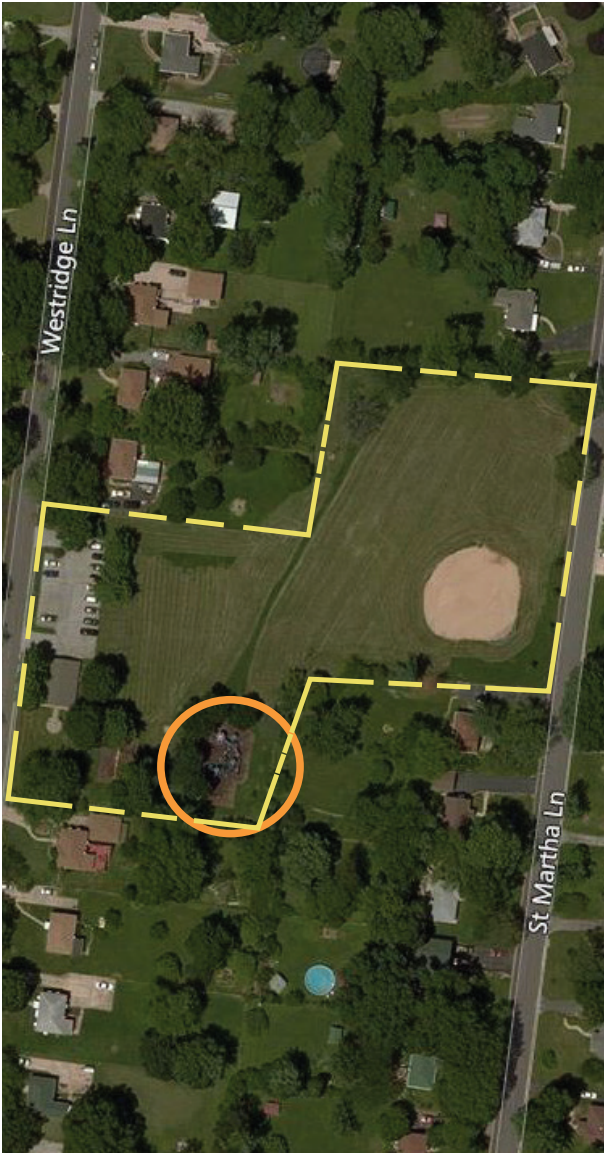
MARY RIDGE PARK

Mary Ridge Park is located between St. Martha Lane and Westridge Lane in Ward 1. The park consists of three acres with one baseball diamond, one grill, one comfort station, one horseshoe pit, one pavilion, and one playground.

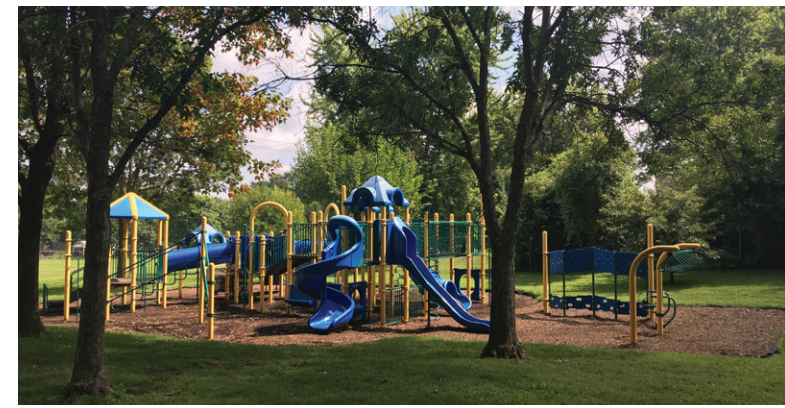
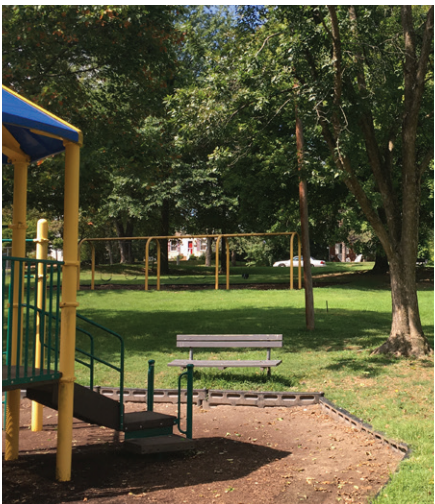
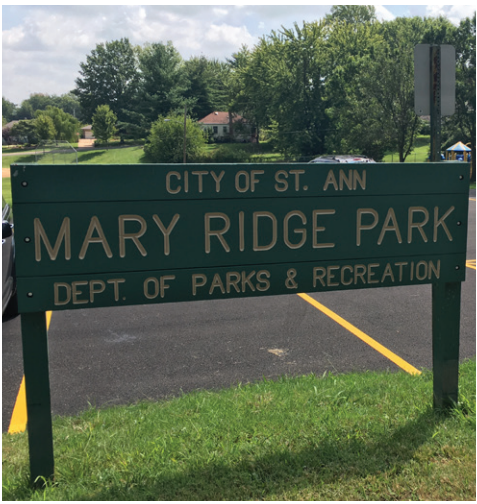
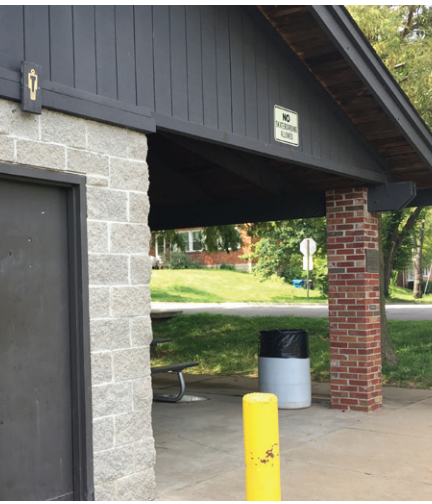
The playground at Mary Ridge Park was installed in 2000 and was manufactured by Playworld. There is a significant change in elevation from the parking lot and shelter down to the playground, and an accessible walk is not provided to playground area. The playground surfacing is mulch, and benches at the boundary of the playground. The shelter at the parking lot provides picnic tables, restrooms, and a drinking fountain.

Mary Ridge Park	Score	Comments	Recommendations
Structures & Location	Ward		One	
	Manufacturer		Playworld	
	Year Installed		2000	Annual inspection by a CPSI professional
Equipment & Accessibility	Age	0	Playground was installed more than 15 years ago	City should consider replacement of the playground in long-range planning for the park
	General Conditions	3	Structures in good condition, one swing is missing and playground is dirty but not visibly damaged	Equipment is well-maintained and should continue so based on CPSI inspections until replacement; missing swing should be replaced
	Paved Accessible Walk	0	There is no existing walk	Install accessible path to connect to play area, consider connecting to restroom and shelter as well
	Surfacing	2	Mulch	Install poured-in-place rubber surfacing with replacement to meet city's goal for playground surfacing
	Swings	2	There are swings, but there is not a path to access them.	Add accessible path to swings, install rubber surfacing

The playground at Mary Ridge Park received the highest score of the playgrounds in the City of St. Ann parks system. An accessible walk to the playground would significantly increase the value of the playground to the surrounding community. However, overall the playground is in good condition and this park is not used for major events. The playground has earned high marks for its good condition and amenities which translates to a low recommendation for priority of replacement. Also, consideration should be given to implementing a succession planting of trees to ensure the playground continues to have shade as the current trees age and their health begins to decline.

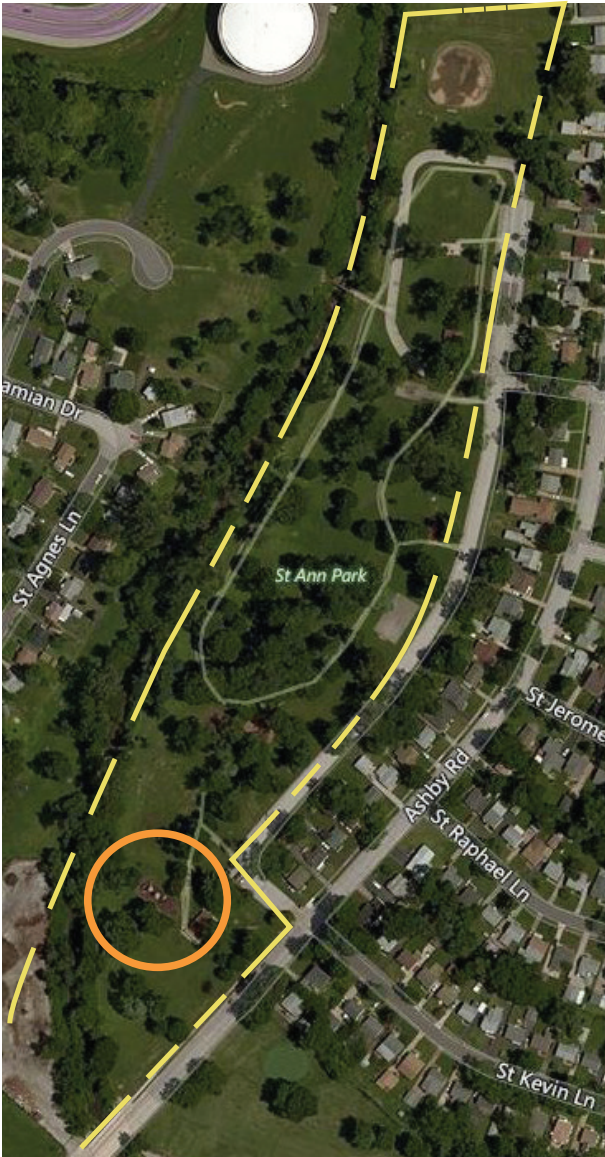
ST. ANN PARK 1

St. Ann Park is on Ashby Road in Ward 2 and occupies thirty-three acres with one baseball diamond, seven grills, a half-basketball court, two comfort stations, two horseshoe pits, two mini shelters, two playgrounds, and a loop walking trail with connections to parking lots and surrounding neighborhoods.

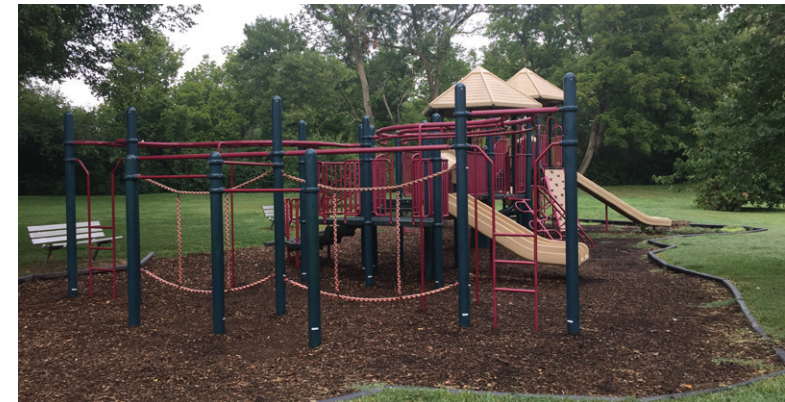
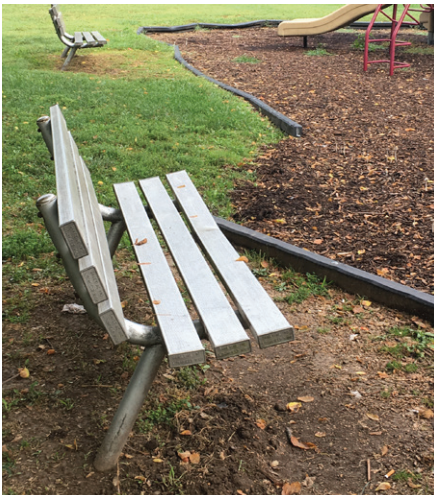
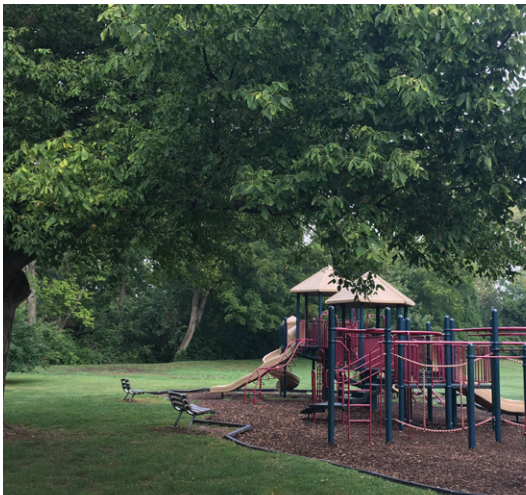
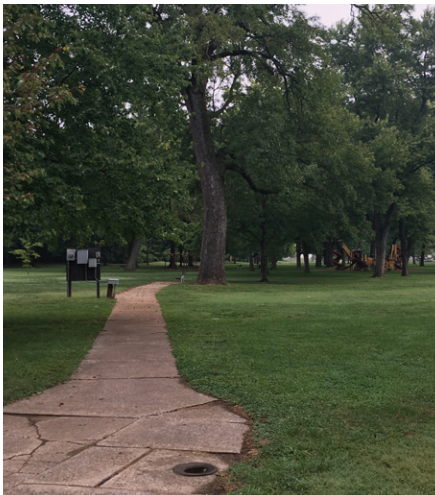
St. Ann Park has two playgrounds. This playground is located at the south end of the park. The surfacing at this playground is mulch, and several benches are located along the playground edging. The nearby shelter provides picnic tables, a drinking fountain and restrooms. A concrete walk connects the shelter to a nearby parking lot and is close to the playground, but this walk does not provide direct access to the playground surfacing or benches around the playground. This playground is often used by adults with disabilities.

St. Ann 1	Score	Comments	Recommendations
Structures & Location	Ward		Two	
	Manufacturer		Miracle	
	Year Installed		1994	Annual inspection by a CPSI professional
Equipment & Accessibility	Age	0	Playground was installed more than 15 years ago	City should consider replacement of the playground in long-range planning for the park
	General Conditions	2	Structures in good condition for their age, need cleaning	Equipment is well-maintained and should continue so based on CPSI inspections until replacement
	Paved Accessible Walk	2	There is a path to the playground; it does not meet ADA requirements	Renovate walk to make accessible with a minimum width of five feet. The use of this playground by adults with special needs makes this accessible walk a high priority for this playground.
	Surfacing	2	Mulch (only partially mulched, soil is exposed in some areas)	Install poured-in-place rubber surfacing with replacement to meet city's goal for playground surfacing

Swings	0	There are no swings at this playground	Swings could be added to enhance the play experience if desired by the community
	Inclusive Play	0	There are no inclusive elements and the park is used for events	Inclusive play would be highly beneficial as this park draws high traffic due to camps and events that are held in the park
Comfort & Convenience	Site Furnishings	1	There are benches near the playground and nearby shelter	Ensure these items meet ADA guidelines with future improvements
	Shaded Play Area	1	The playground is partially shaded by nearby trees	Trees should be evaluated by a certified arborist as part of a park maintenance program for deadwood or hazardous conditions and addressed per arborist recommendations
	Restroom	1	There is a restroom nearby, but there is not a direct path to from the playground	Concrete walk should connect this amenity to the playground for ADA access

Playground 1 at St. Ann Park is ranked in the middle of the seven playgrounds in the City of St. Ann parks system. There are several improvement updates that can be completed on a short timeline and relatively small budget that would improve the playground and increase the value within the system, extending the timeline for replacement. These include completing the refill of mulch surfacing and connecting the concrete walk to the playground. This playground is used often by adults with disabilities and special events, so an accessible route is very important,. This would be a good playground to consider inclusive elements.

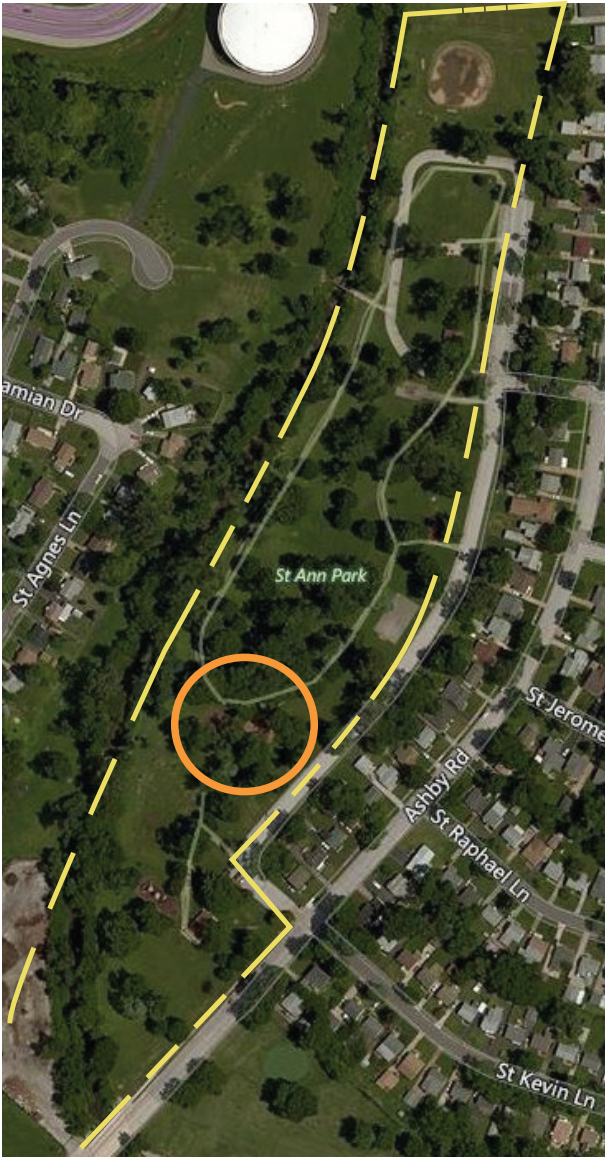
ST. ANN PARK 2

St. Ann Park is on Ashby Road in Ward 2 and occupies thirty-three acres with one baseball diamond, seven grills, a half-basketball court, two comfort stations, two horseshoe pits, two mini shelters, two playgrounds, and a loop walking trail with connections to parking lots and surrounding neighborhoods.

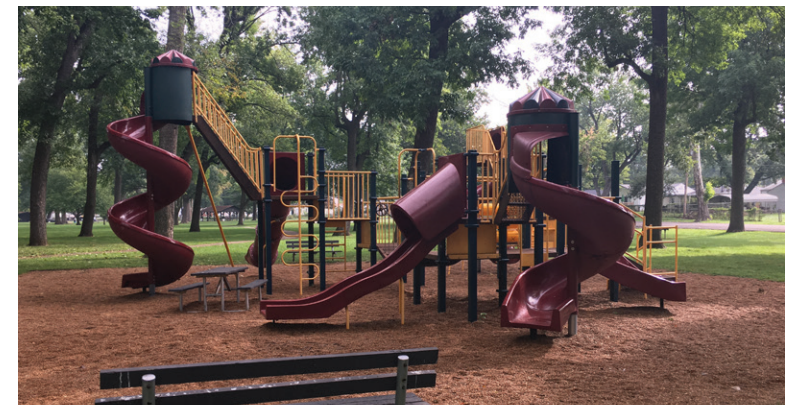
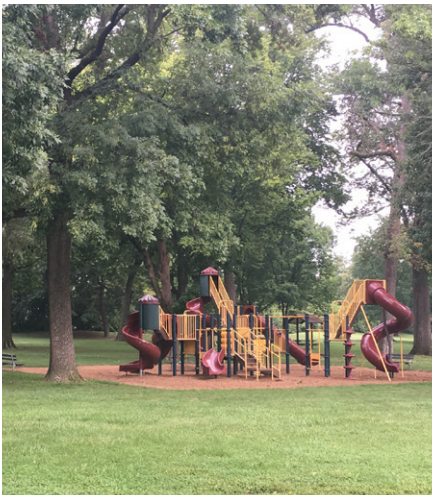
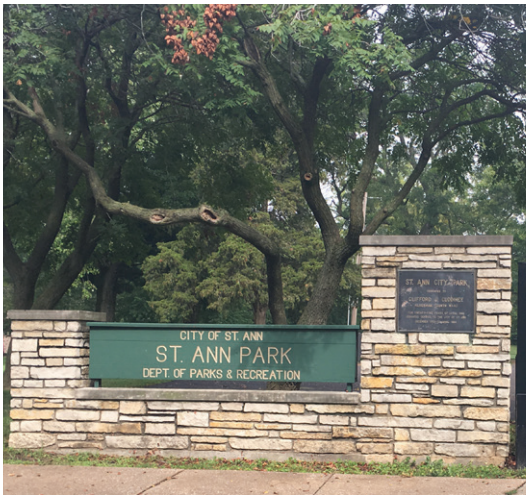
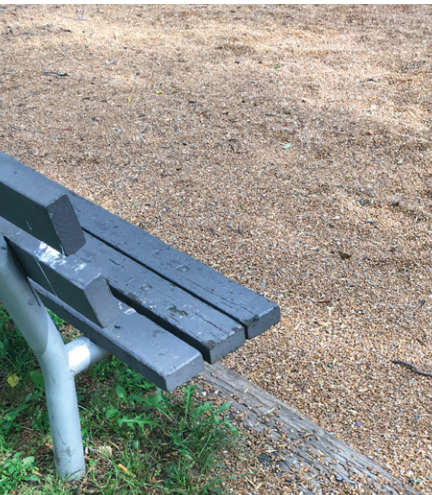
This playground is more centrally located within the park and consists of a structure area and a separate swing area. This playground is not connected to any other park elements with a paved walk. The surfacing is pea gravel, and there are benches along the boundary of the playground. Picnic tables are located within the lawn under tree canopy cover near the play structures. This playground is provided shade by many large tree. There is a mini shelter fairly close, but there is no path connecting the mini shelter to the playground.

St. Ann 2	Score	Comments	Recommendations
Structures & Location	Ward		Two	
	Manufacturer		Miracle	
	Year Installed		1994	Annual inspection by a CPSI professional
Equipment & Accessibility	Age	0	Playground was installed more than 15 years ago	City should consider replacement of the playground in long-range planning for the park
	General Conditions	2	Structures are generally in good condition, there is a cracked slide	Equipment is well-maintained and should continue so based on CPSI inspections until replacement
	Paved Accessible Walk	0	There is no existing walk	Install accessible path to connect to play area, consider connecting to restroom and shelter as well
	Surfacing	0	Pea gravel	Install poured-in-place rubber surfacing with replacement to meet city's goal for playground surfacing. Mulch may be a temporary replacement to provide an accessible surfacing
	Swings	2	There are swings nearby, there is no path to the swings	Add accessible path to swings, install rubber surfacing

Inclusive Play	0	There are no inclusive elements and this park is used for events	Inclusive play would be highly beneficial as this park draws high traffic due to camps and events that are held in the park
Comfort & Convenience	Site Furnishings	1	There are benches near the playground	Ensure these items meet ADA guidelines with future improvements
	Shaded Play Area	1	The playground is shaded well by large trees	Trees should be evaluated by a certified arborist as part of a park maintenance program for deadwood or hazardous conditions and addressed per arborist recommendations
	Restroom	1	There is a restroom	Paved walk should be extended to connect this amenity to the playground for ADA access
	Picnic Shelter	1	There is a shelter	Paved walk should be extended to connect this amenity to the playground for ADA access
	Drinking Fountain	1	There is a drinking fountain	Paved walk should be extended to connect this amenity to the playground for ADA access

Playground 2 at St. Ann Park received the third-lowest ranking. It should be a high priority for replacement as it is highly-used and the park hosts large city events. This would be a playground to consider making a destination and/or including inclusive elements or those that target specific age groups as it is in a prominent park within the St. Ann Parks System. Specialized playground opportunities are outlined in the appendix.

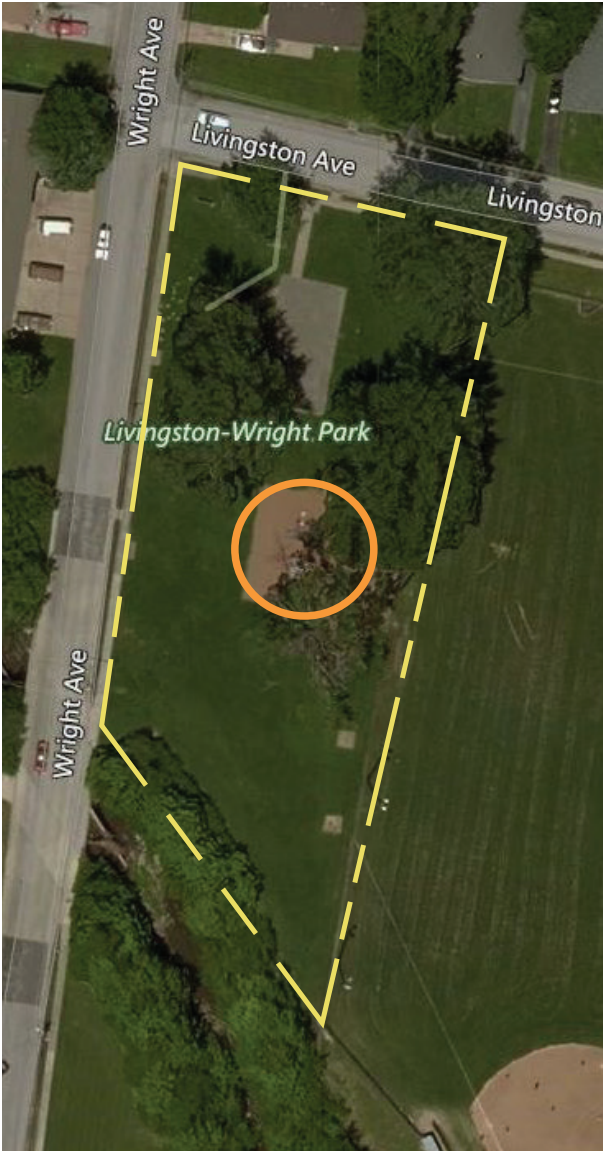
LIVINGSTON/WRIGHT PARK

Livingston/Wright Park is a half-acre park located at the corner of Livingston Avenue and Wright Avenue in Ward 1. The park has one playground, one small shelter, one grill, and one horseshoe pit.

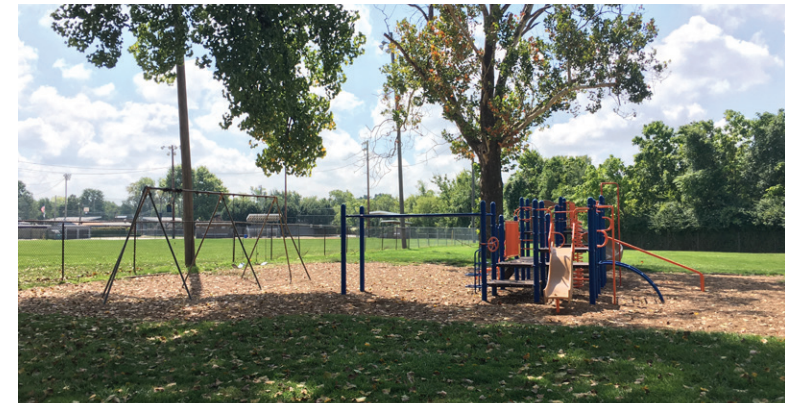
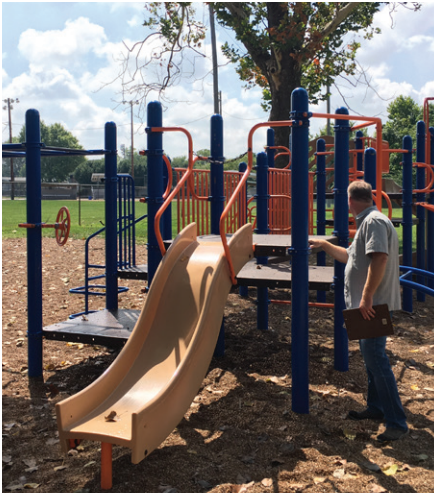
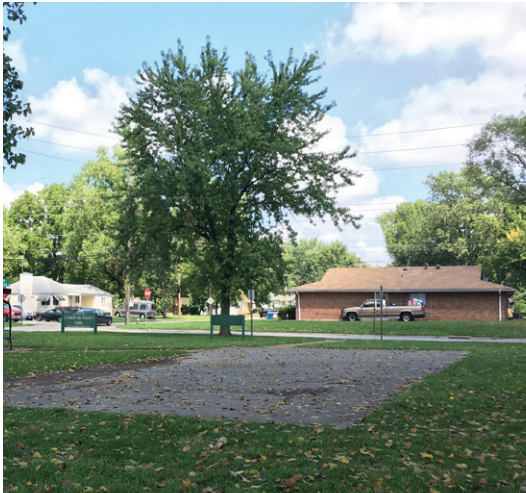
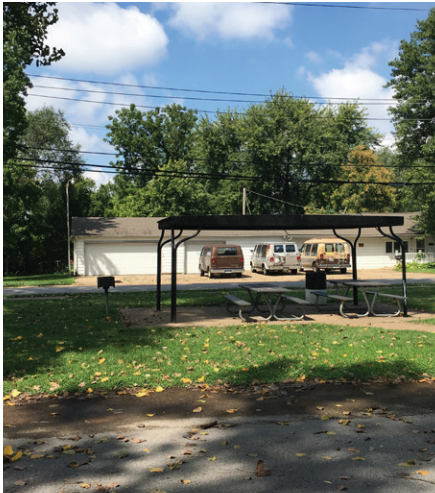
The park does not contain internal paved walks or connections to the park features. There is no restroom or drinking fountain provided within the park.

Livingston/ Wright Park	Score	Comments	Recommendations
Structures & Location	Ward		One	
	Manufacturer		Iron Forge	
	Year Installed		1991	Annual inspection by a CPSI professional
Equipment & Accessibility	Age	0	Playground was installed more than 15 years ago	City should consider replacement of the playground in long-range planning for the park
	General Conditions	2	Structures are in good condition, some chipped paint and rubber coating	Equipment is well-maintained and should continue so based on CPSI inspections until replacement
	Paved Accessible Walk	0	There is no existing walk	Install accessible path to connect to play area, consider connecting to restroom and shelter as well
	Surfacing	0	Pea gravel	Install poured-in-place rubber surfacing with replacement to meet city's goal for playground surfacing. Mulch may be a temporary replacement to provide an accessible surfacing
	Swings	2	There are swings, they are only belt swings	Add accessible path to swings, install rubber surfacing

Inclusive Play	2	There are no inclusive elements and the park is not used for camps or events	This park is not used for camps or events, but could still benefit from inclusive elements, but this is a low priority due to the low traffic of the playground
Comfort & Convenience	Site Furnishings	0	There are no nearby site furnishings	Consider adding benches near the playground and ensure these items meet ADA guidelines
	Shaded Play Area	0	Shade is not provided at play area (existing trees are in bad condition)	Trees should be evaluated by a certified arborist as part of a park maintenance program and addressed per arborist recommendations
	Restroom	0	There is no restroom	not recommended to add a restroom
	Picnic Shelter	1	There is a small picnic shelter	
	Drinking Fountain	0	There is no drinking fountain	not recommended to add a drinking fountain
	Lighting (Security)	0	There is no lighting at playground area	Consider adding lighting for safety and security

it is not recommended to invest in significant change to the playground without considering replacement of the entire playground due to the age of the structures and pea gravel surfacing.

While this playground received the lowest ranking the recommendation for priority of replacement is not high due to the low usage of the playground. The structures are in good condition for their age and are not in high demand for events or general usage.
